# JAMESON THERIAULT MARINE SURVEYS

## CONDITION & VALUATION SURVEY

“CAROL LINDA”

Condition & Valuation Survey for Resale,  
Banking and Insurance Purposes

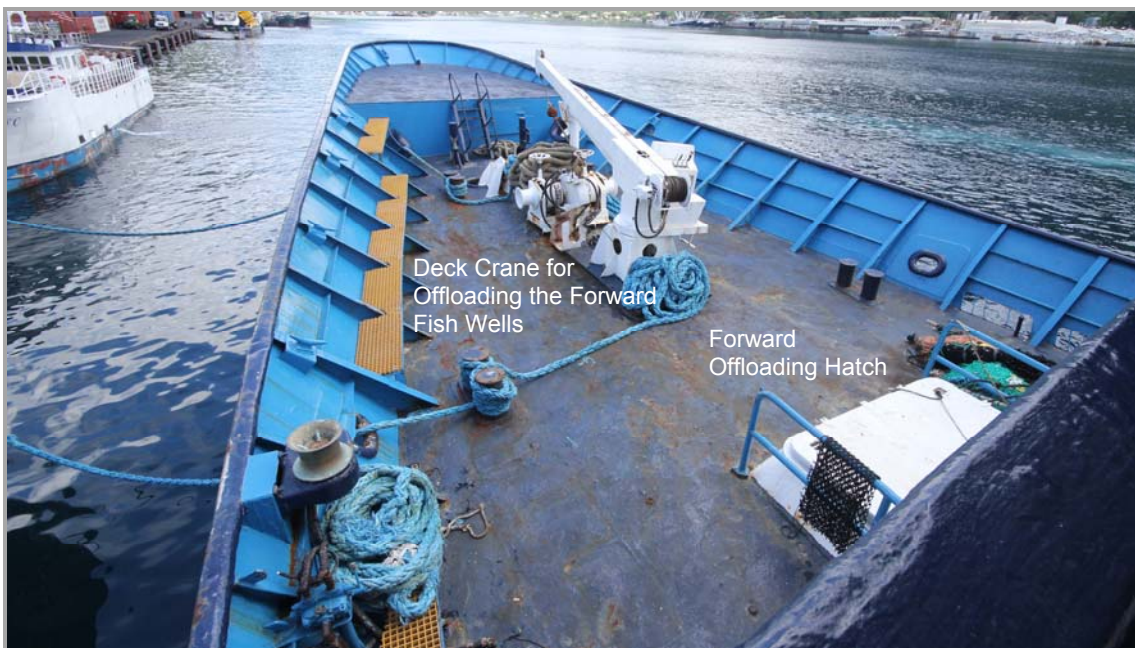
Deck Crane for  
Offloading the Forward  
Fish Wells

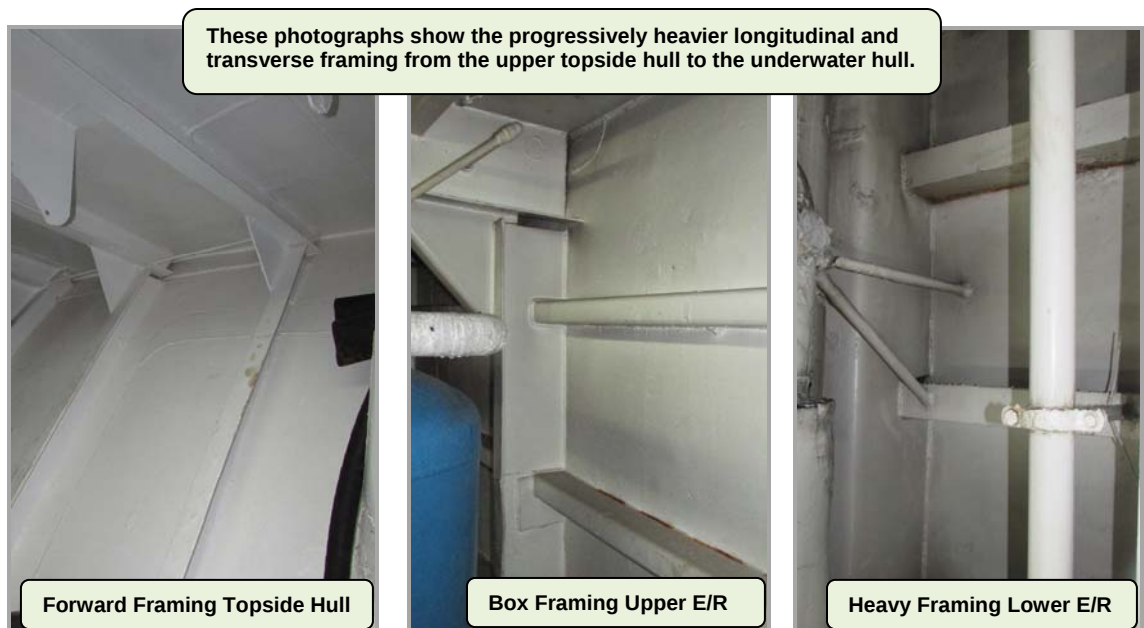
Condition of Exposed Frames

The readily accessible and exposed framing was in serviceable condition (no apparent structural deficiencies and paint coatings in good condition). Note - we observed documentation showing significant frame maintenance and repair during a 2009 refit at Ching-Fu Shipbuilding Co. in Taiwan.

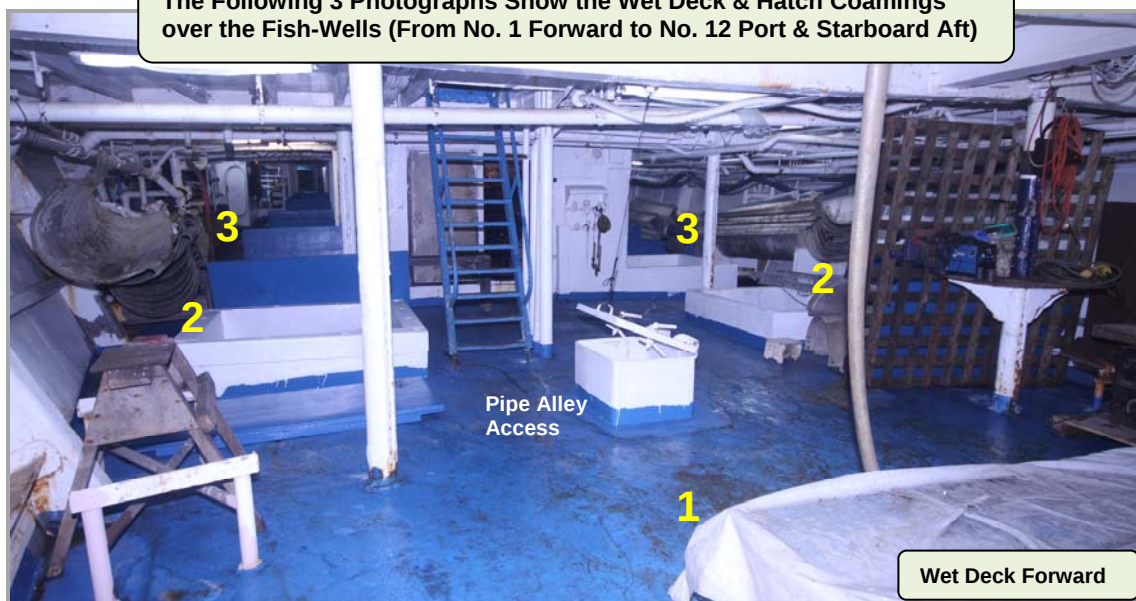
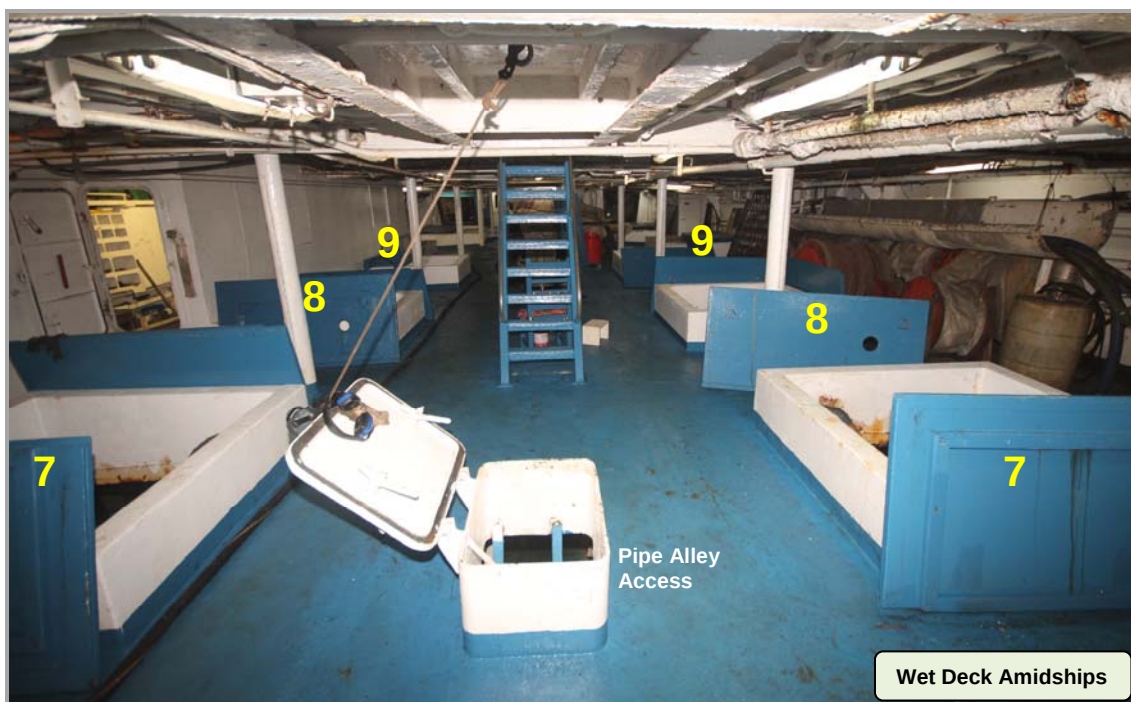
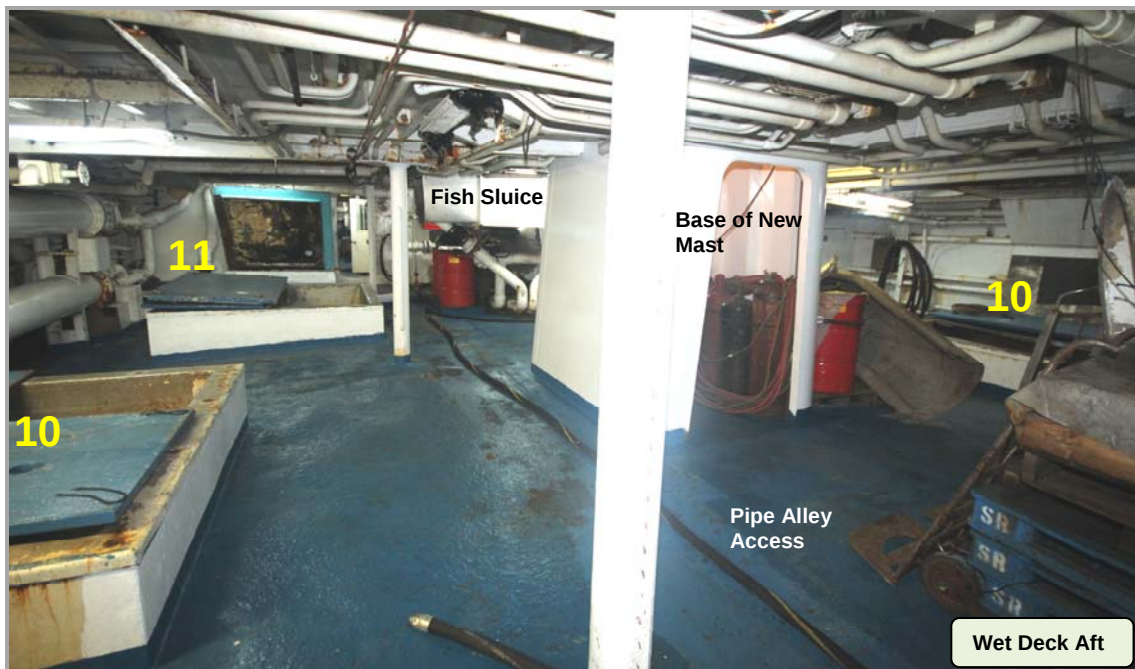
Fish-wells no. 1 and no. 2 (port and starboard) were 90% drained. Fish-wells no. 3 - no.12 (port and starboard) were filled with water (regular practice for stability purposes).

The Following 3 Photographs Show the Wet Deck & Hatch Coamings over the Fish-Wells (From No. 1 Forward to No. 12 Port & Starboard Aft)

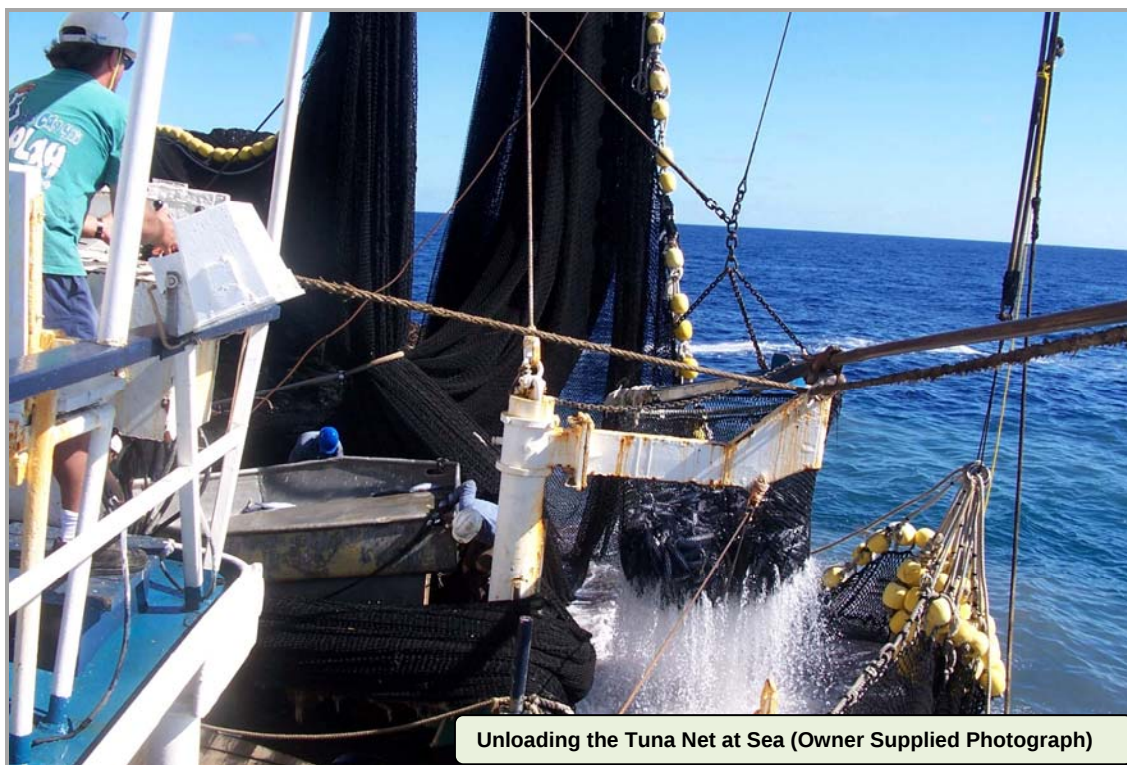
Unloading the Tuna Net at Sea (Owner Supplied Photograph)

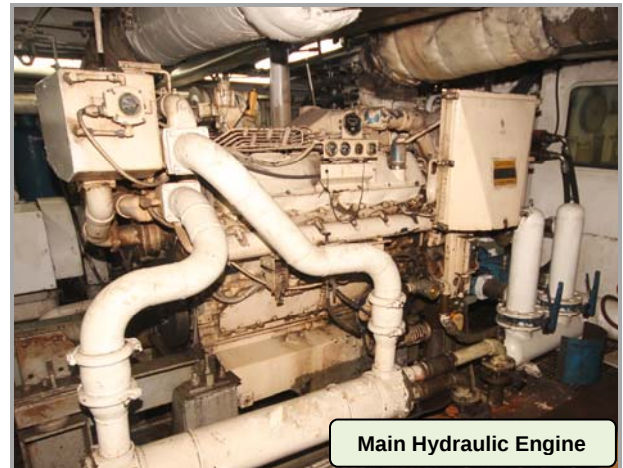
Main Hydraulic Engine

The engine was maintained in good working order (it started right off and performed well during the survey).

The engine had acquired 7,041 hours of use since the last rebuild (date of rebuild unconfirmed).

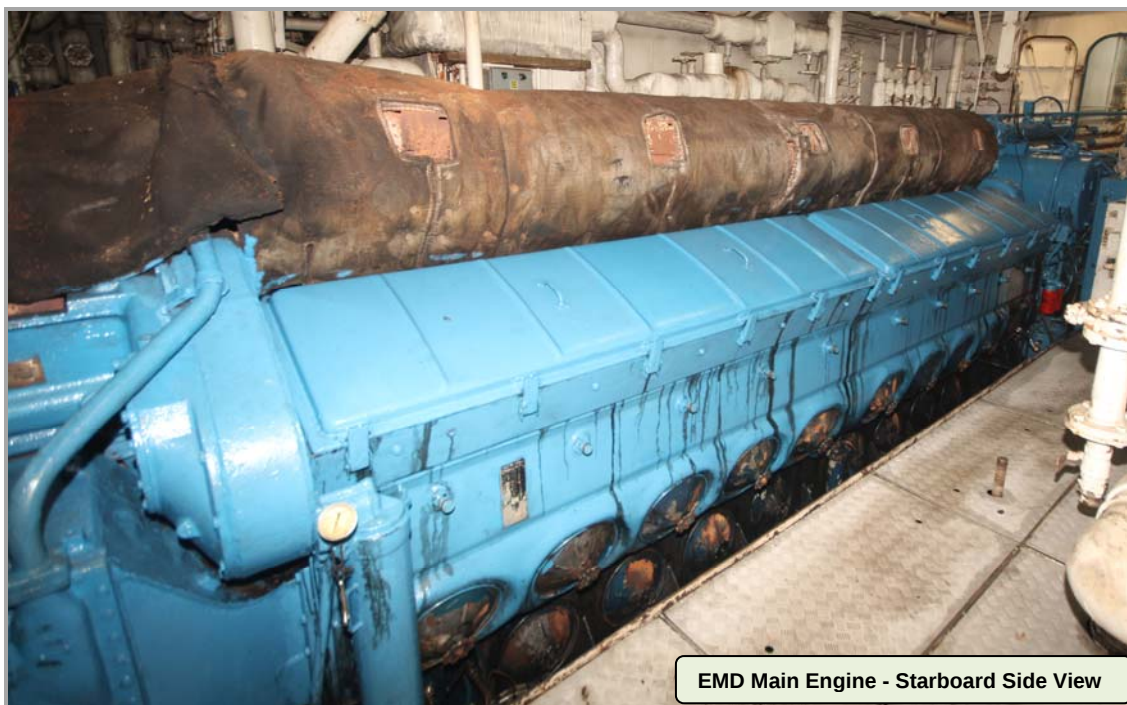
**EMD Main Engine - Starboard Side View**

The engine was well painted and free of external rust and corrosion. There were oil leaks around the seals (a common sign of wear), but the engine was reportedly consuming lubricating oil at a normal rate (24 hours reported running between top-ups).

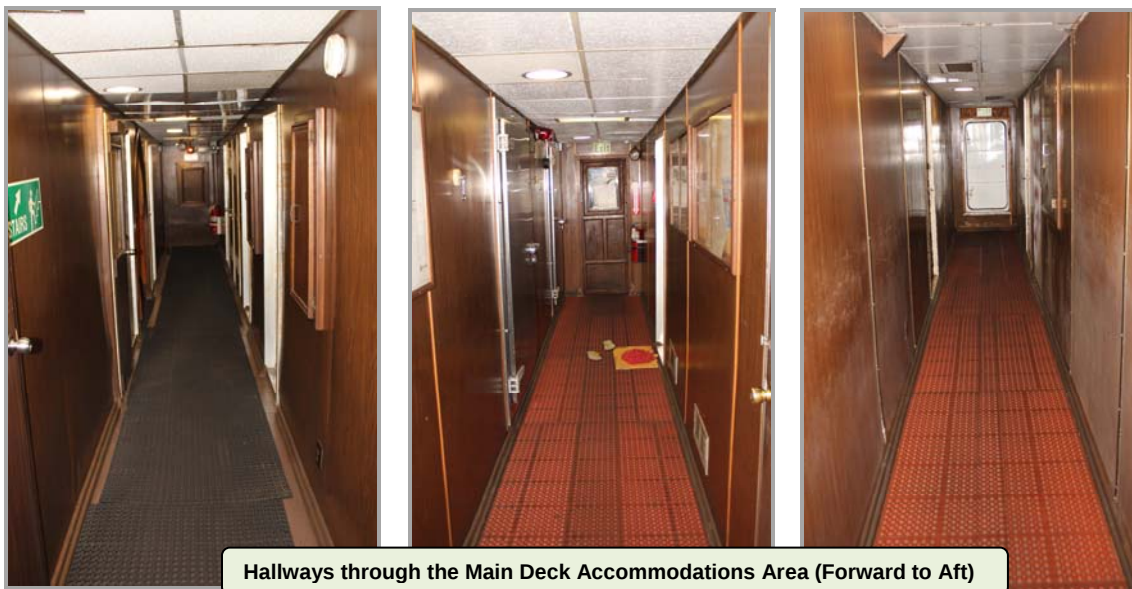
Hallways through the Main Deck Accommodations Area (Forward to Aft)

With random exceptions of localized wear and tear, the finish work was in reasonably good overall condition. Some of the ceiling tiles were discoloured from age.

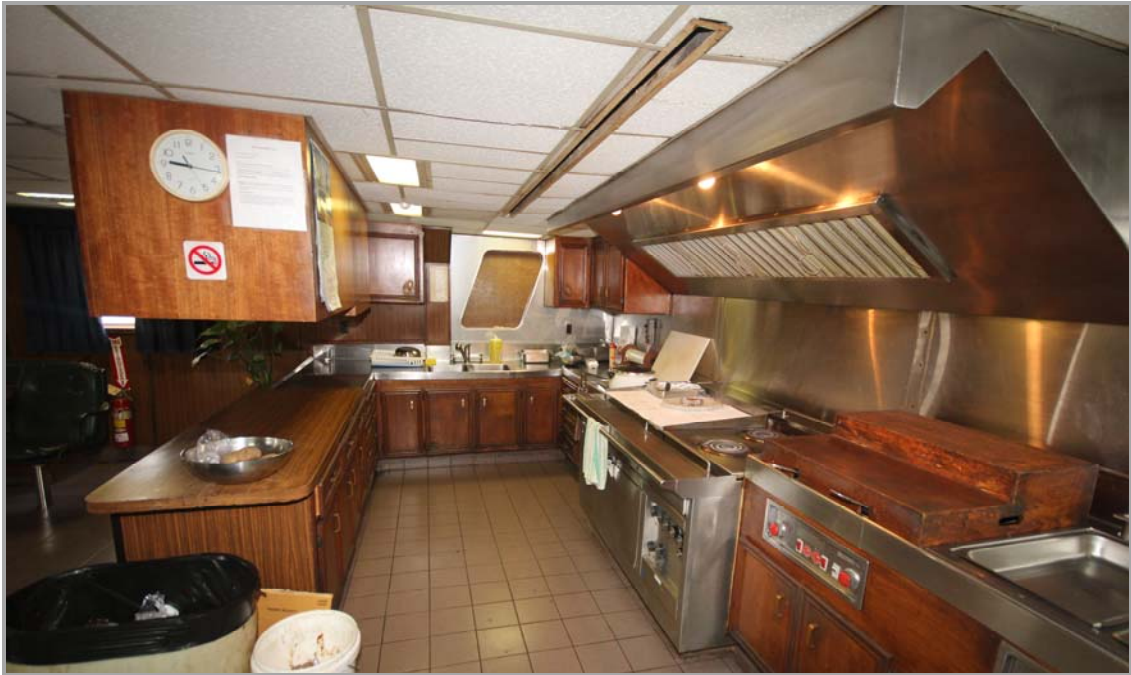
Full Service Galley

Over the 5 days we were onboard the cook provided regular (excellent) meals using all galley appliances except the warmer. The oven, warmer and fridge had some issues and were in need of service. (**See Maintenance Issues**)

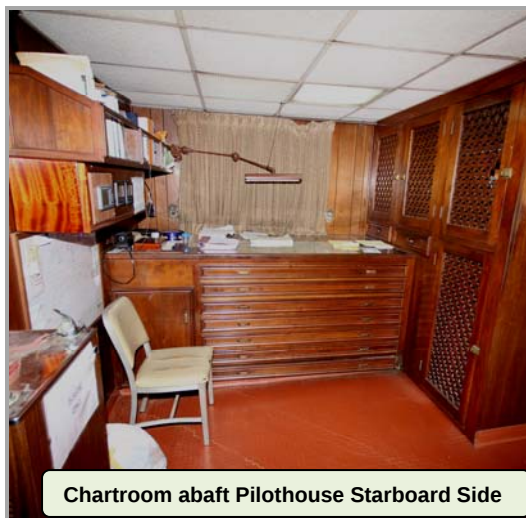
Chartroom abaft Pilotouse Starboard Side

These areas were clean and presentable and the finish work was in good condition.

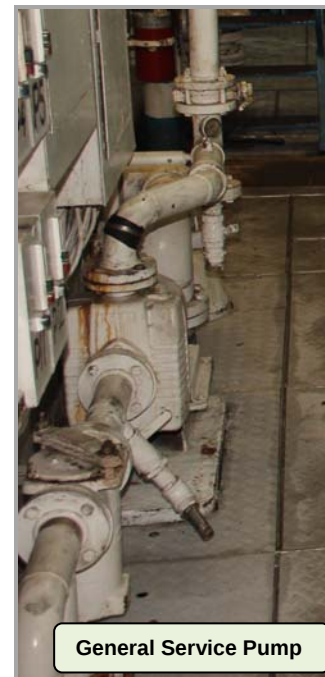
General Service Pump

Owing to age the steel seawater lines (fill lines for the fish-wells, bilge suction, etc.) should be examined for corrosion, cropped and replaced as necessary in the not-too distant future in keeping with prudent maintenance practices.

Owing to age, the steel fuel pipes and all seawater pipes (including the fish-well intake pipes and the bilge suctions) should be specifically examined and repaired as necessary in the not-too-distant future in keeping with prudent maintenance practices.

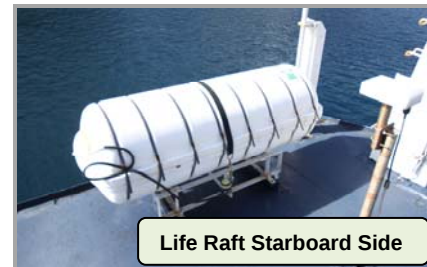
2007 Beaufort 25-person life raft with hydrostatic release.

The life raft inspection certificate expired in April 2015 (**See Recommendations**).

The hydrostatic release expires in April 2017.

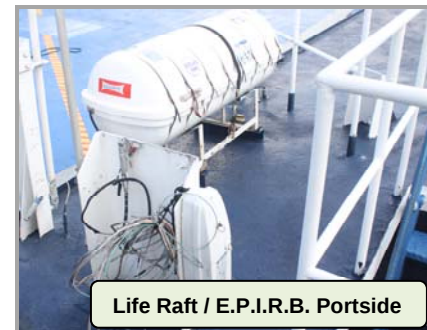
2007 Beaufort 25-person life raft with hydrostatic release.

The life raft inspection certificate and the hydrostatic release expired in April 2015.

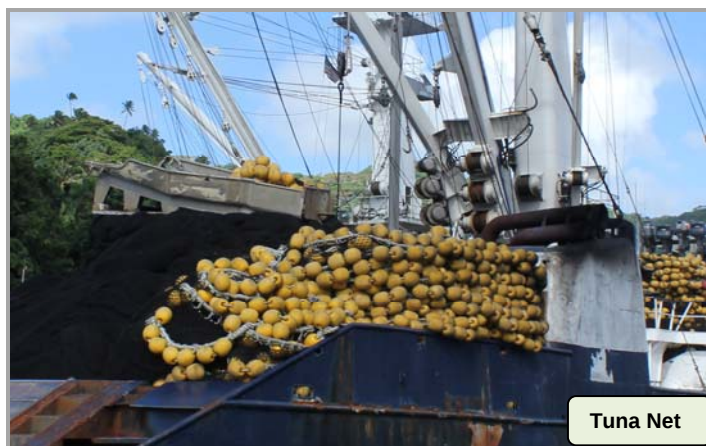
Part of a net was stored aft on the boat deck (far right in the adjacent photograph).
