# JAMESON THERIAULT MARINE SURVEYS

## CONDITION & VALUATION SURVEY

“CAROL LINDA”

Condition & Valuation Survey for Resale,  
Banking and Insurance Purposes

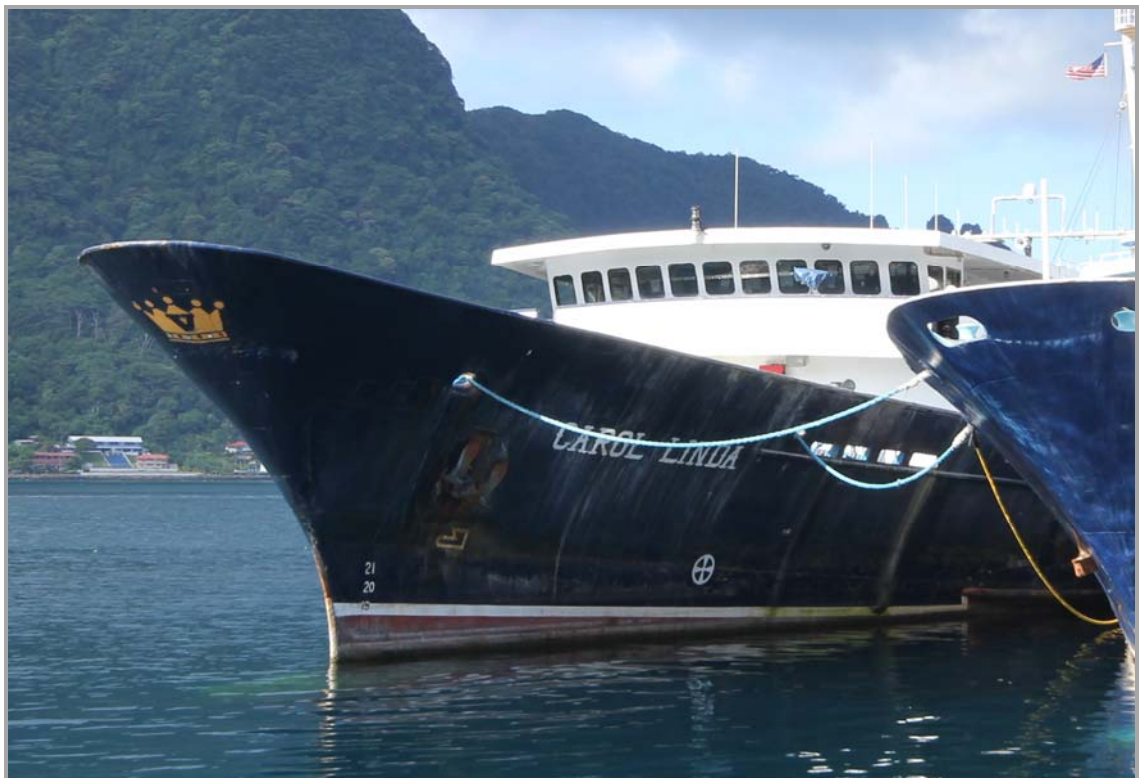
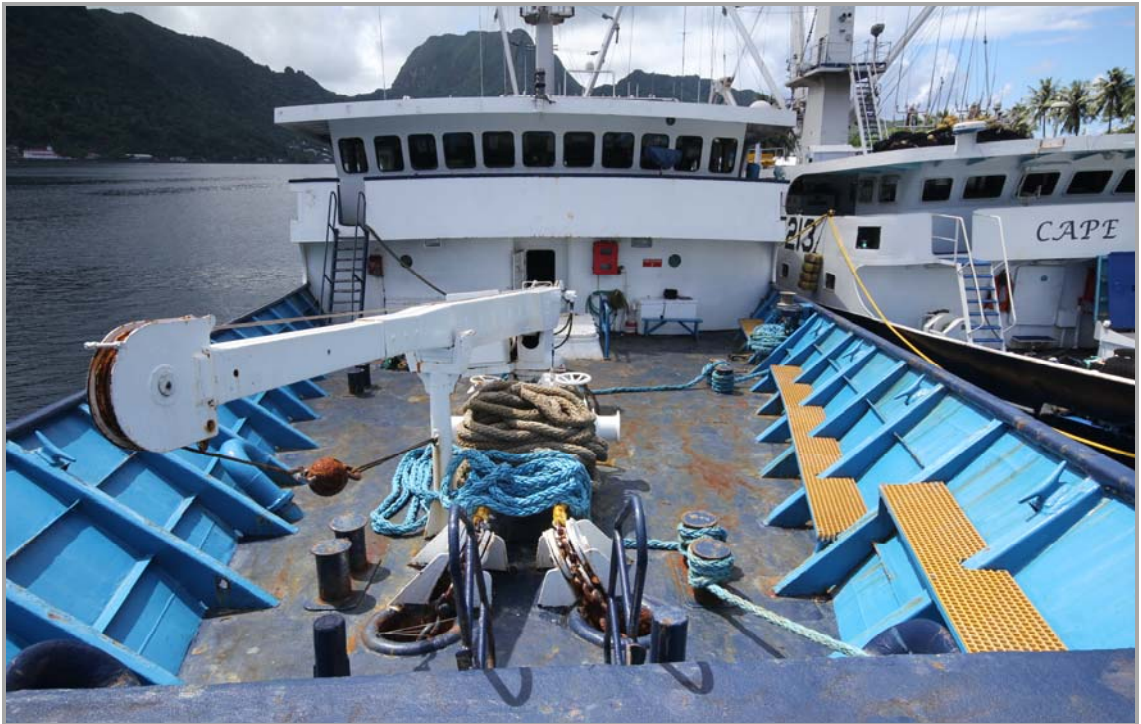
Views of the Forward Deck

There was light to moderate scaling on the exposed plating on the forward deck. The hawse pipes were notably corroded with deeper scaling. There was scaling along the inside of the bulwark rails around the forward deck and, to a lesser extent, the work deck aft. These areas should be sandblasted and recoated in keeping with prudent maintenance practices. **(See Maintenance Issues)**

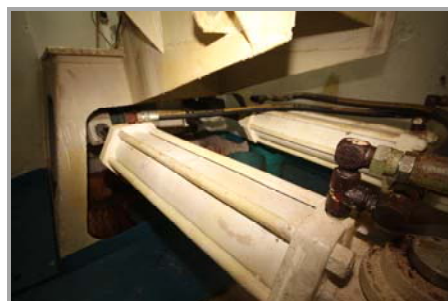
Steering Gear / Rudder Gland

The steering gear was maintained in good condition.

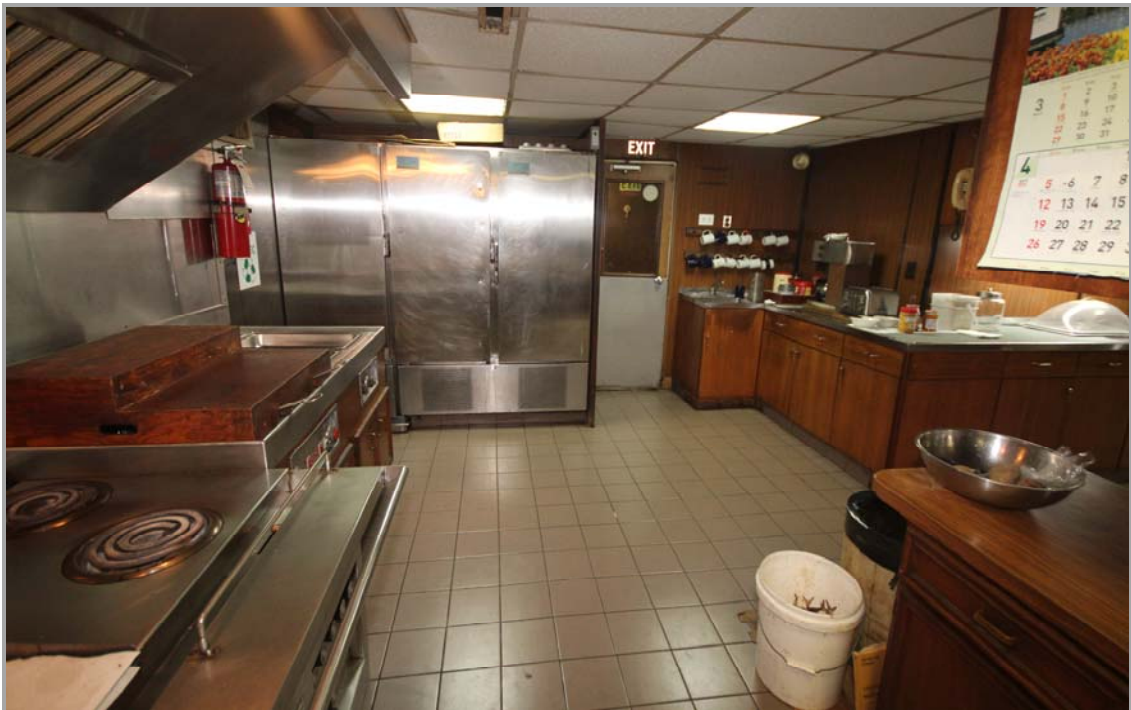
Full Service Galley

The galley was fitted with a commercial grade Edlund stove with grill and range hood, deep fryer and warmer, Glenco fridge and walk in freezer. Other items included a microwave oven, toaster and a well-used coffee maker.

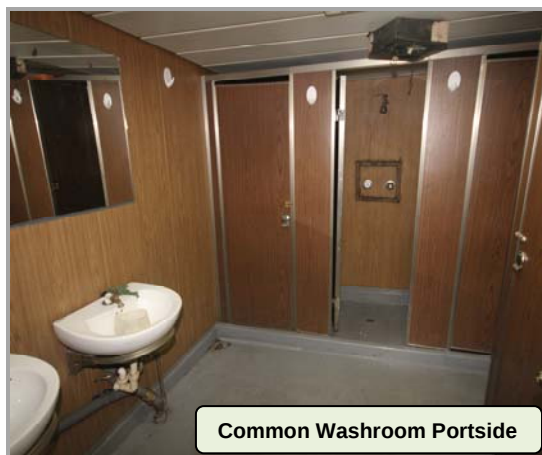
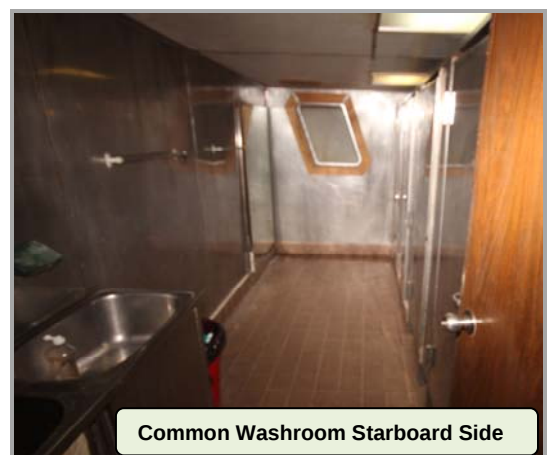
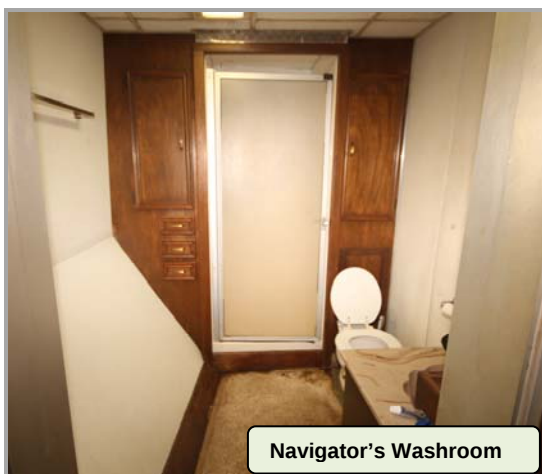
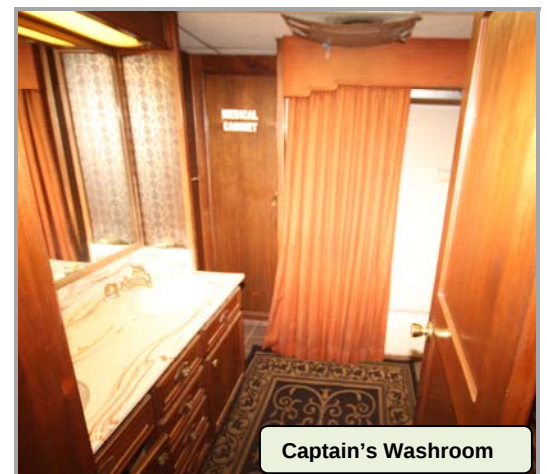
The finish work in the private and shared washrooms was in average overall condition. The finish work in the 2 common washrooms was in need of repair with worn shower stalls and doors, etc. (**See Maintenance Issues**)

The taps, fixtures and associated plumbing in all of the washrooms was worn and in need of general refit - the toilets worked, but some of the showers were inoperable. (**See Maintenance Issues**)

The washer and dryer in the laundry room were in working order, but were well used.

The finish work in the 2 common washrooms was in need of repair with worn shower stalls and doors, etc. Refurbish all deteriorated finish work as necessary in keeping with prudent maintenance practices.

The taps, fixtures and associated plumbing in all of the washrooms was worn and in need of general refit - the toilets worked, but some of the showers were inoperable.

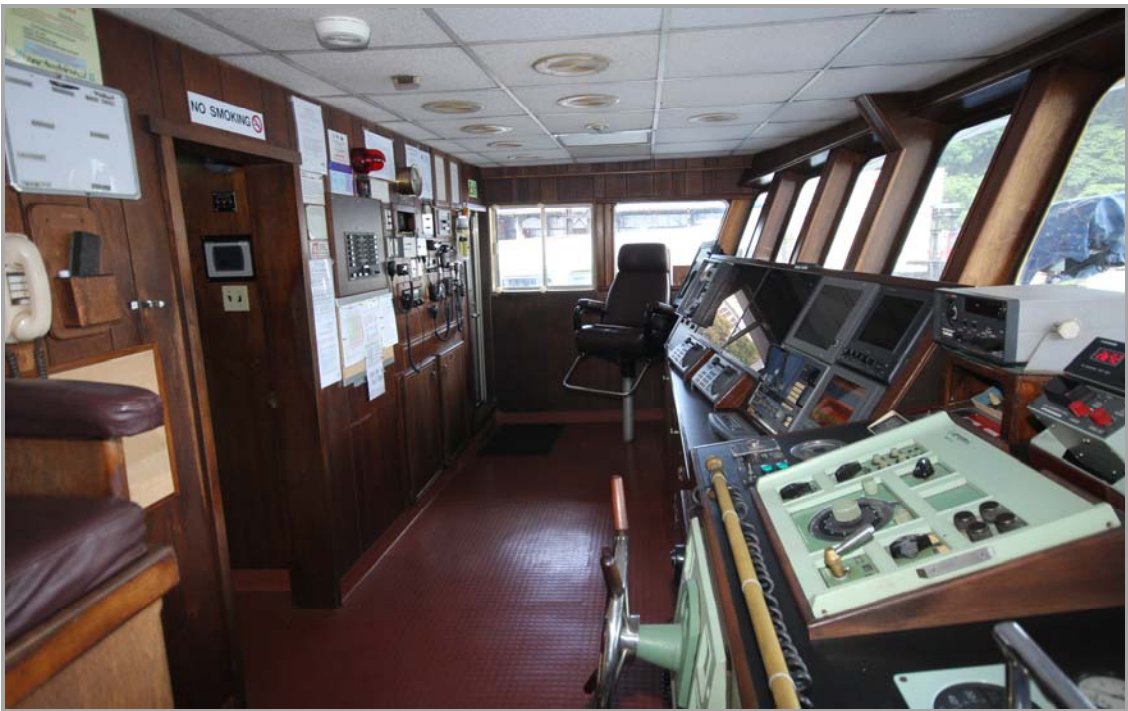
Well Appointed Pilothouse - Starboard & Portside Views

The magnetron in the Furuno radar on the portside had excessive hours of use (over 4000) and should be replaced.

The sonar was not working and the dome would not extend electronically (it had to be manually cranked). There were some new replacement sonar parts onboard.

The magnetron in the Furuno radar on the portside had excessive hours of use (over 4000) and should be replaced.

The Furuno sonar was not working and the dome would not extend electronically (manually crank only). Service as necessary. Note - there were some new sonar replacement parts onboard.

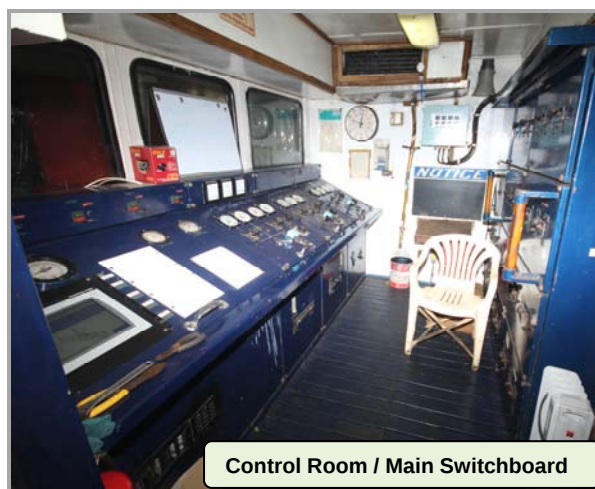
The no. 2 gen-set was operating for the 5 days we were onboard and aside from a few burnt bulbs in the overhead lighting, there were no apparent problems.

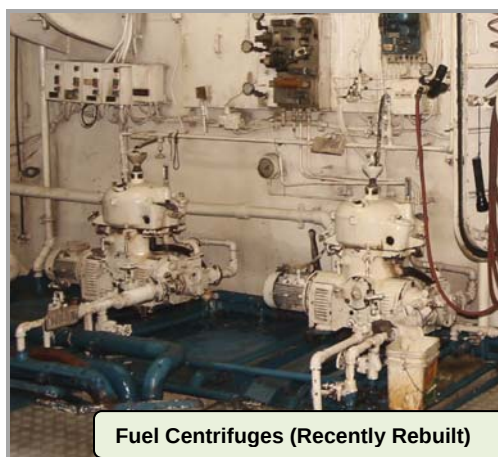
The 2 fuel centrifuges were overhauled in 2015 (these ensure a clean fuel supply to the engines).

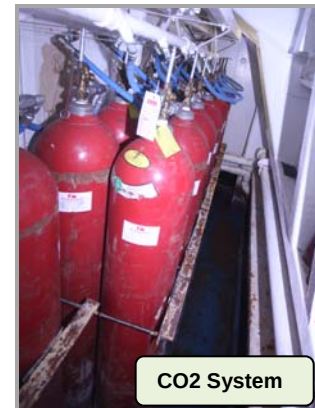
Primary CO2 system positioned aft on the wet deck with secondary system (for the bow thruster room) forward on the wet deck. The system was last serviced in March 2014.

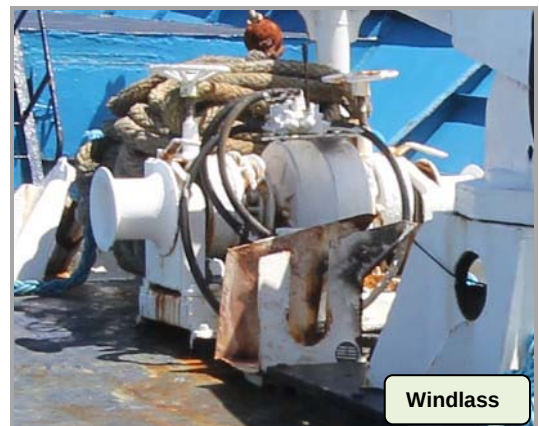
The windlass was maintained in operable condition and was fitted with suitably sized stud-link chain.

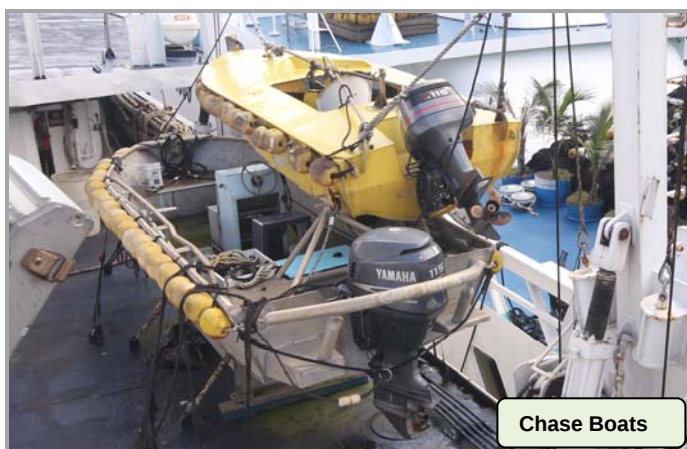
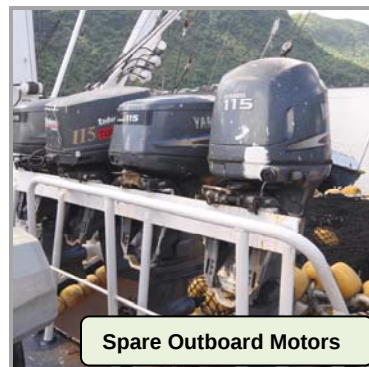
The chase boats were in serviceable condition. Spare outboard motors were stored onboard. There was a dedicated workshop and fuel supply tank for the support boats on the boat deck.
